**Docket No. 217 – Development and Management Plan Inspection**

**Date:** December 8, 2005

**Location:** Norwalk Substation Expansion

**Location:** Plumtree Substation Expansion, Bethel

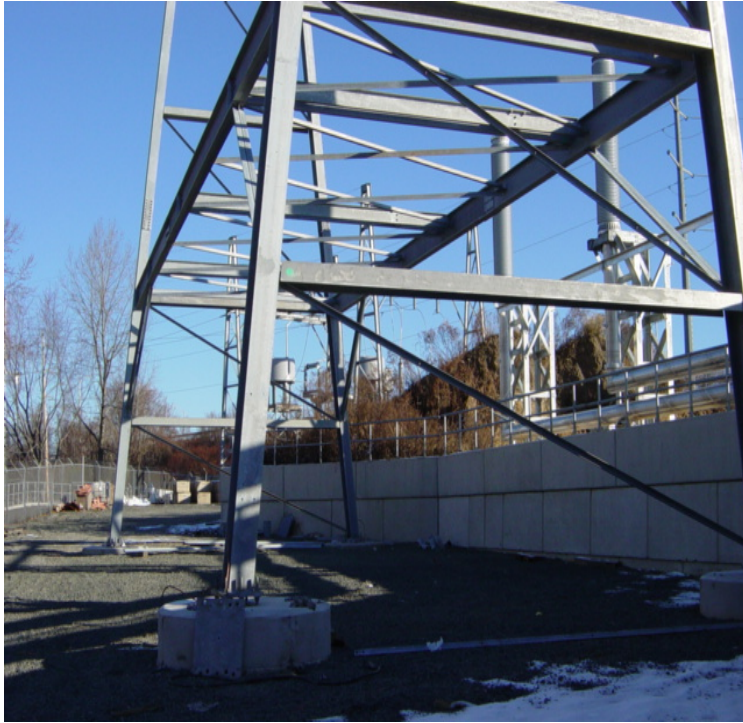
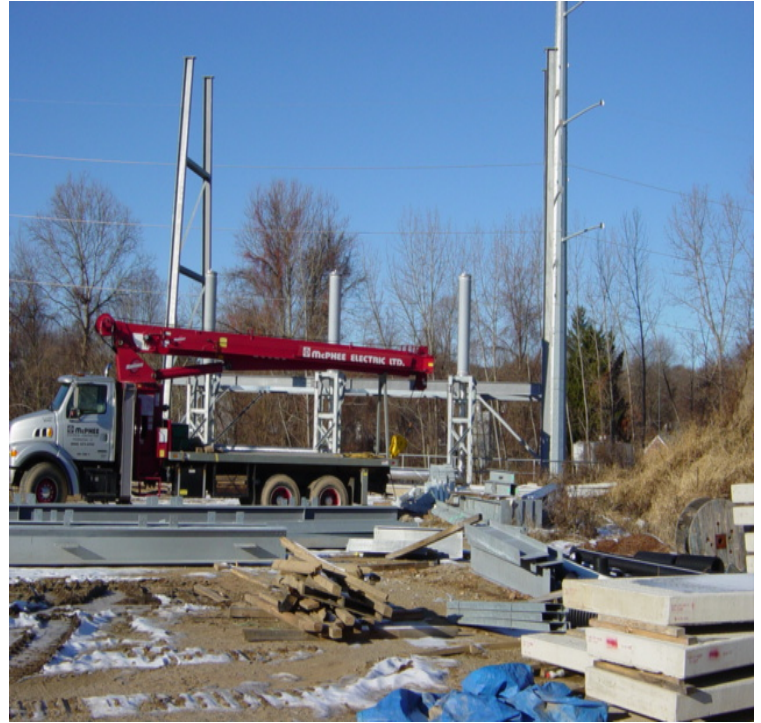
Norwalk Substation: Both photos show views of the structures being installed adjacent to the bike path and retaining wall to the northwest of the GIS building. 12/8/05.

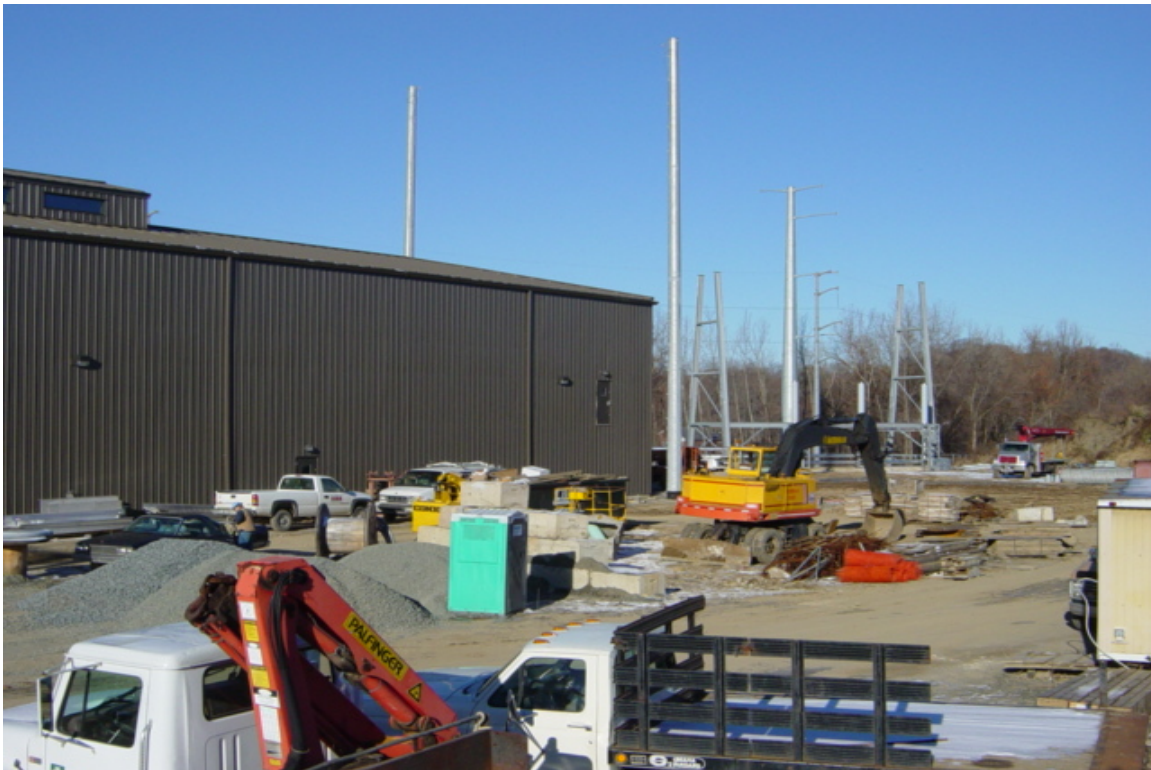
Areas of Inspection	Observation	Recommended Action
Access Roads and Adjacent Roadways	<ul style="list-style-type: none"> <li>- The access roads on site are now paved. Portions of the yard adjacent to the GIS building remain porous. 12/8/05</li> <li>- The catch basin near the Route 7 ramp receives a lot of off-site stormwater, and erosion is occurring here. 12/8/05.</li> </ul>	<ul style="list-style-type: none"> <li>- None at this time. 12/8/05</li> <li>-The area should no longer be affected by any onsite sediment. The access road is paved and the swale is vegetated The silt fence should be removed. 12/1-12/8/05.</li> </ul>
Foundation construction	<ul style="list-style-type: none"> <li>-Work continues on steel structures to the north and northwest of the yard between the retaining wall and the bike path.12/1-12/8/05</li> <li>- The topsoil stockpile remains in the adjacent yard area to the GIS building. Areas to the east of the building remain unpaved with a few stone piles in place. 12/8/05.</li> <li>- Work was no longer observed at the northern portion of the site near the ROW. 12/8/05</li> <li>-The 345kV turning structure work is complete. 12/8/05</li> </ul>	<ul style="list-style-type: none"> <li>-None at this time. Observable progress was noted. 12/1-12/8/05.</li> <li>- The stockpiles are contained well within the yard. 12/8/05.</li> <li>- Continue to maintain erosion controls adjacent to the river here until stablized.12/8/05</li> <li>-We just need confirmation that all proposed grades were met here. 11/10-12/8/05.</li> </ul>

Overview of the yard adjacent to the GIS building which remains unpaved. 12/8/05.

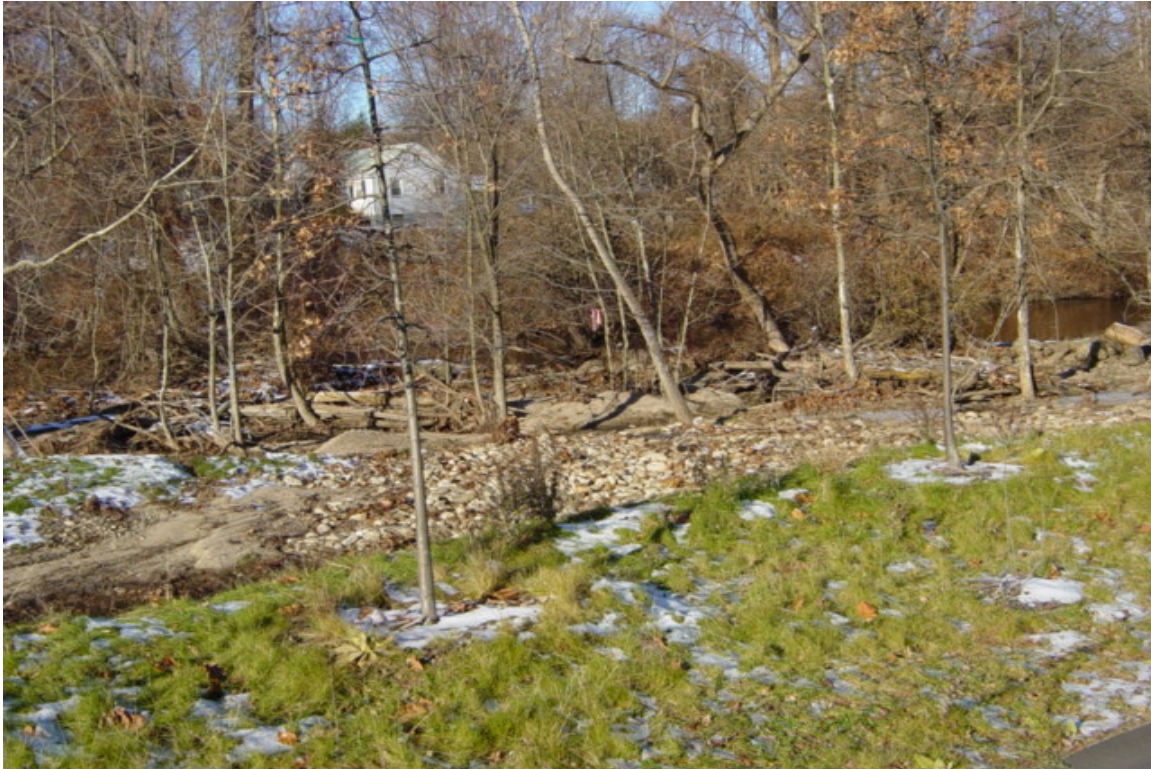
Inland Wetland and Watercourse encroachment and mitigation	-Water has been flowing clear in both the natural and constructed overflow channel, but additional small sediment/sand piles were noted here when the water receded. 12/8/05.	- Try to determine whether the loose sediment noted is project related. This may be natural deposition by the river. 12/8/05.
State species of concern, threatened and endangered species	- No species of concern are located in this area of construction.	- N/A
Vegetative clearing limits (including trees to save or danger trees noted)	-No additional clearing is needed at this time. 12/8/05	- Clearing was limited to what is necessary and it will continue to be monitored. 12/8/05
Dewatering	-Dewatering was not observed during this inspection. 12/8/05.	-None at this time. 12/8/05.
Blasting	- No blasting is occurring on site at this time and it is not anticipated to be necessary.	- None at this time.

View of the confluence of the river with the constructed overflow channel where sediment accumulation continues after each flooding/high water level event. 12/8/05.

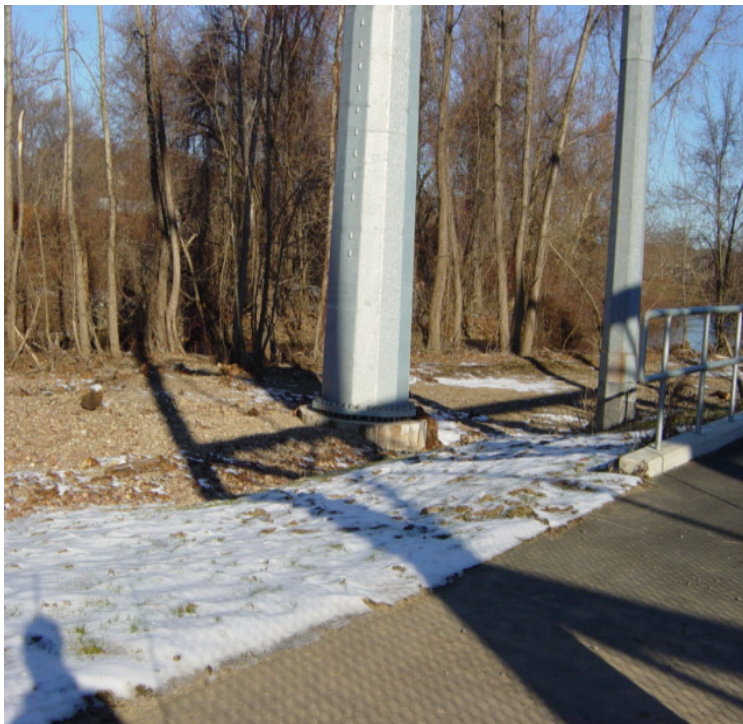
Photo on the left shows the 345kV turning structure where some of the sediment may be washing from. Photo on the right shows Plumtree Substation where most substation related work here is complete. 12/8/05.
